CASE STUDY MALL NEAR SECUNDA

Background

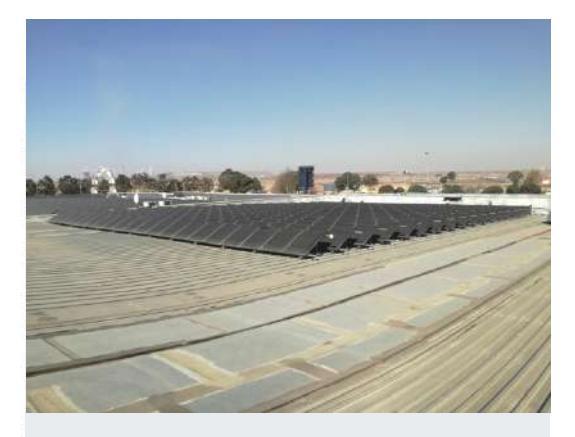
In 2015, a grid-tied solar plant was built on the roof of the mall by a competitive solar construction company, using thin film panel technology. In 2018, a large section of this solar plant was damaged in a fire, after which many of the panels were destroyed.

New Southern Energy stepped in to replace the solar panels that had been damaged in the fire and to restore the solar plant's functionality. At the same time, NSE needed to address the system's reporting challenge.

New Southern Energy replaced a large portion of the panels and inverters as follows:

Old panels: Solar Frontier 170 Wp Thin Film Solar Modules x 4160, total DC power = 707.2 kWp New panels: Canadian Solar 330 Wp Polycrystalline Solar Modules x 950, total DC power = 313.5 kWp

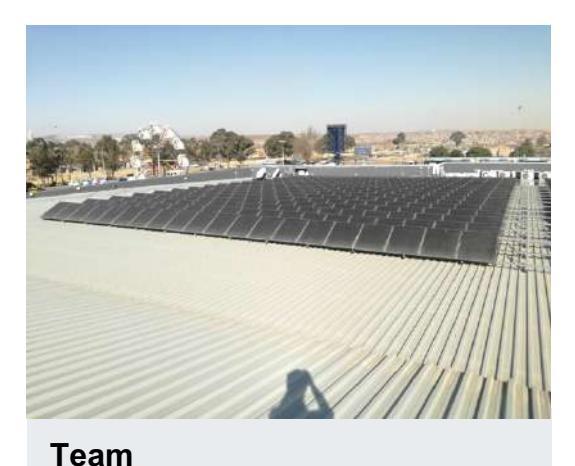
The system's performance is now monitored and controlled through a master controller, which can also communicate with the inverters. All of the data is logged and saved in cloud-based storage. Furthermore, the performance can be monitored in real time via a smart phone app.
